**THE APPROPRIATE USE OF GEOLOGICAL
INFORMATION IN THE DESIGN AND
CONSTRUCTION OF THE EGNATIA
MOTORWAY TUNNELS**

Εισηγητής : Paul G. Marinos and Evert Hoek

**Ιωάννινα, 7 & 8/12/2001
"ΕΓΝΑΤΙΑ ΟΔΟΣ Α.Ε."
& Ε.Ε.Σ.Υ.Ε.**

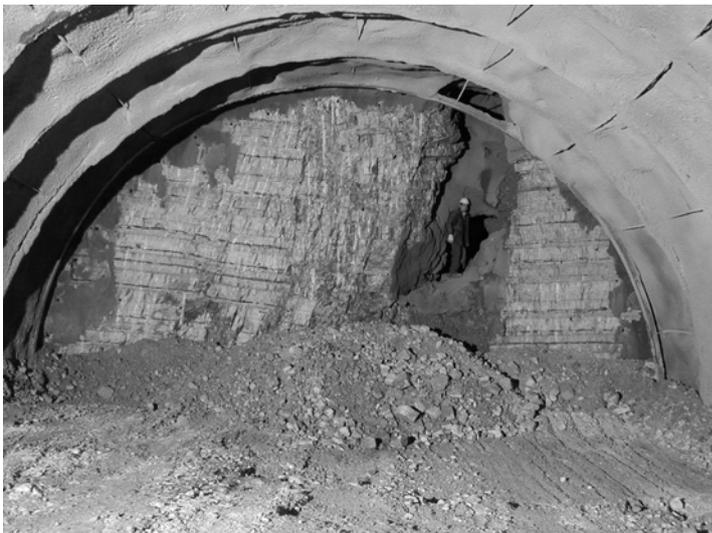
Figure 7: Typical appearance of a small karstic void partially filled with clay and silt; Dodoni Tunnel, northwest Greece, 2000 (Photo taken from site engineer)

The Dodoni tunnel in northern Greece, with a length of 3.3 km is being driven in a limestone sequence with well developed bedding and possible local intercalations of siltstones or cherts a few cm or dm of thickness. The limestone encountered so far has behaved well and this behavior is expected to continue. However, significant overbreaks have occurred at some locations and these overbreaks were mainly due to instability of the fill in karstic cavities even in depths under a cover of 100 m (Fig. 7).

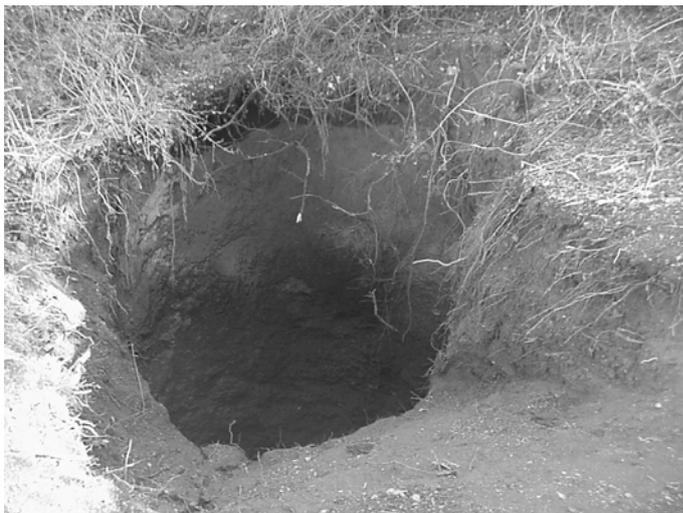
Figure 8: Collapse of the filling of a karstic chimney crossed by Dodoni Tunnel. The collapse outcropped on the surface about 100 m over the tunnel

Two major collapses occurred related to the presence of sinkholes at the surface with outcropping chimneys almost 100 m of height. The voids were filled with clayey material and pieces of broken rock and were prominently wet. The main collapse had a diameter of approximately 1.5 m in the tunnel and 3 m on the surface (Fig. 8), leading to 1200 m³ of material falling into the tunnel.

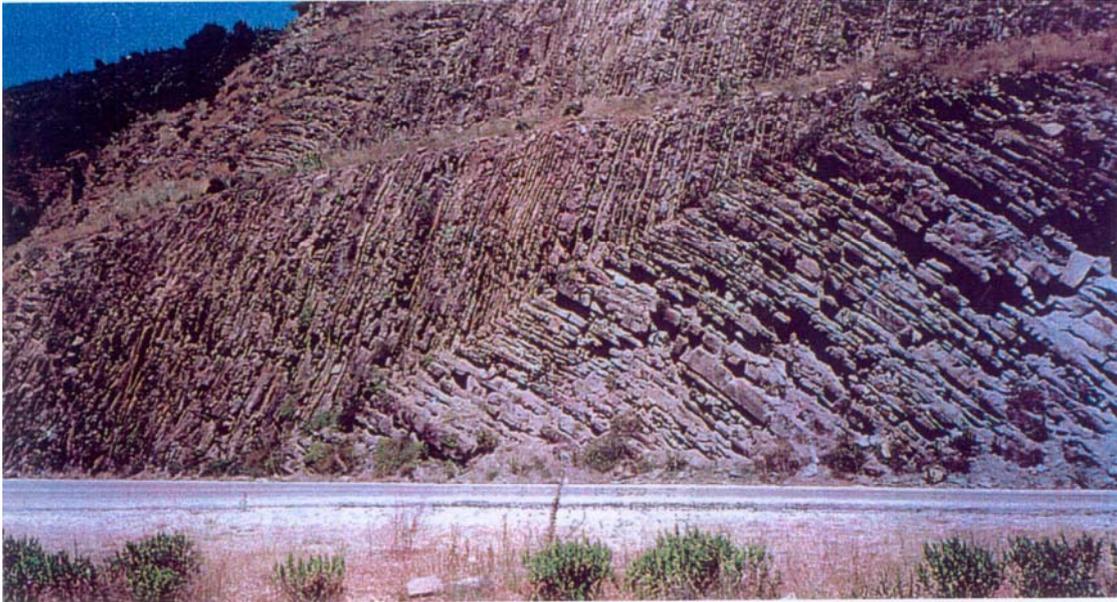
Figure 9: Medium to thick-bedded sandstones and thin-bedded siltstones. It is noted the angular folds and the fracturing (faults) along the axial plains (Photo taken by the designer).

The main part of the tunnel of 4.570 m long will be excavated through flysch comprising zones of siltstone or claystone with thin beds of sandstone alternating with sandstones with thin beds of siltstones. Conglomerates may also occur. Folds and faulted zones are present (fig. 9).

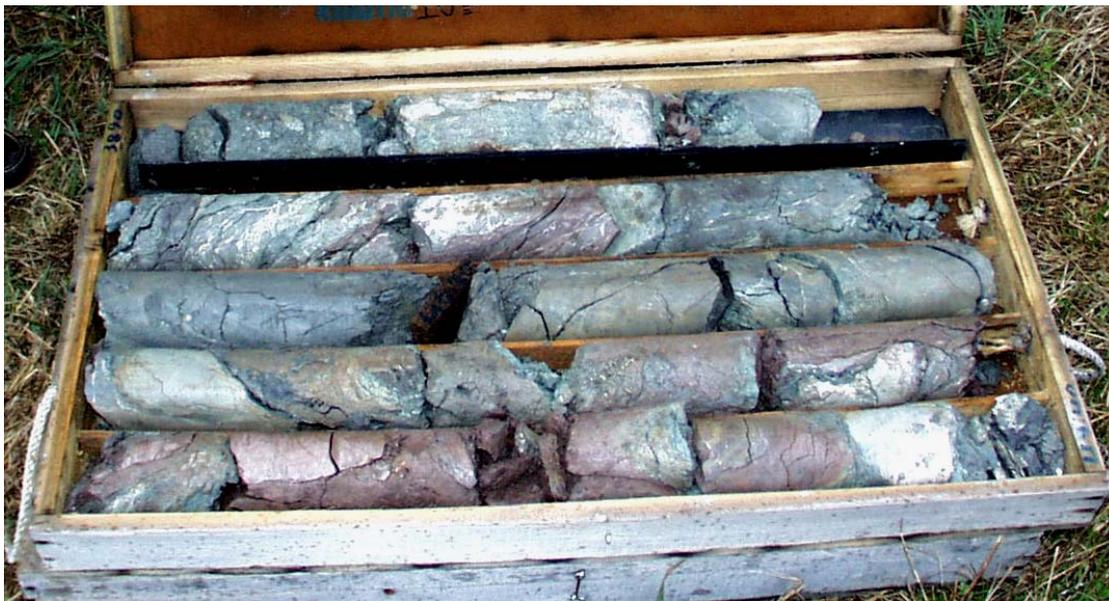
Figure 13: Core from Borehole MB3, Anthochori tunnel

This tunnel is located at the left side of the Metsovitikos valley. The area to be crossed by this 690 long tunnel is located close to the frontal area of the big thrust where the Pindos Unit has moved tectonically over the Ionian Unit. Obviously the main thrust movement is associated with satellite shears within the thrust body. These shears are generally marked by the reddish siltstone sequence of the Pindos flysch. The tunnel is located in such a tectonic body of the Pindos Unit. This body is between two shear zones (satellite thrusts) close to the big Pindos/Ionian thrust (see fig. 12). It has thus suffered from large compression and very weak rock masses have been produced and are likely to be found close the shear zones (fig. 13).

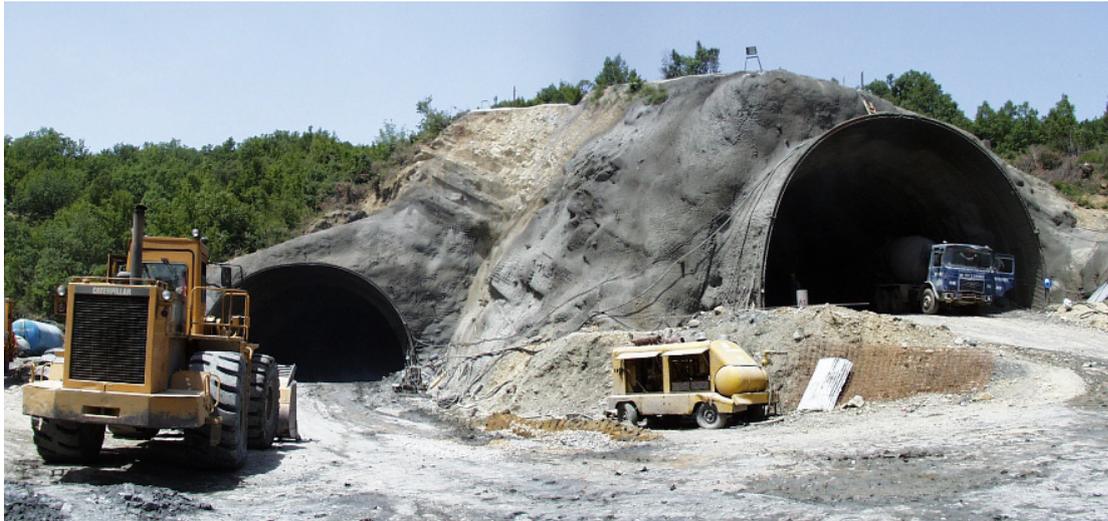
Figure 14: Panoramic view of the east portal of the Anthochori tunnel.

The geological conditions in the Anthochori tunnel are as severe as any encountered thus far on the Egnatia project. The sheared flysch, very weak and deformable produced large deformations ahead of and around the tunnel and great care is taken to control these deformations at present.

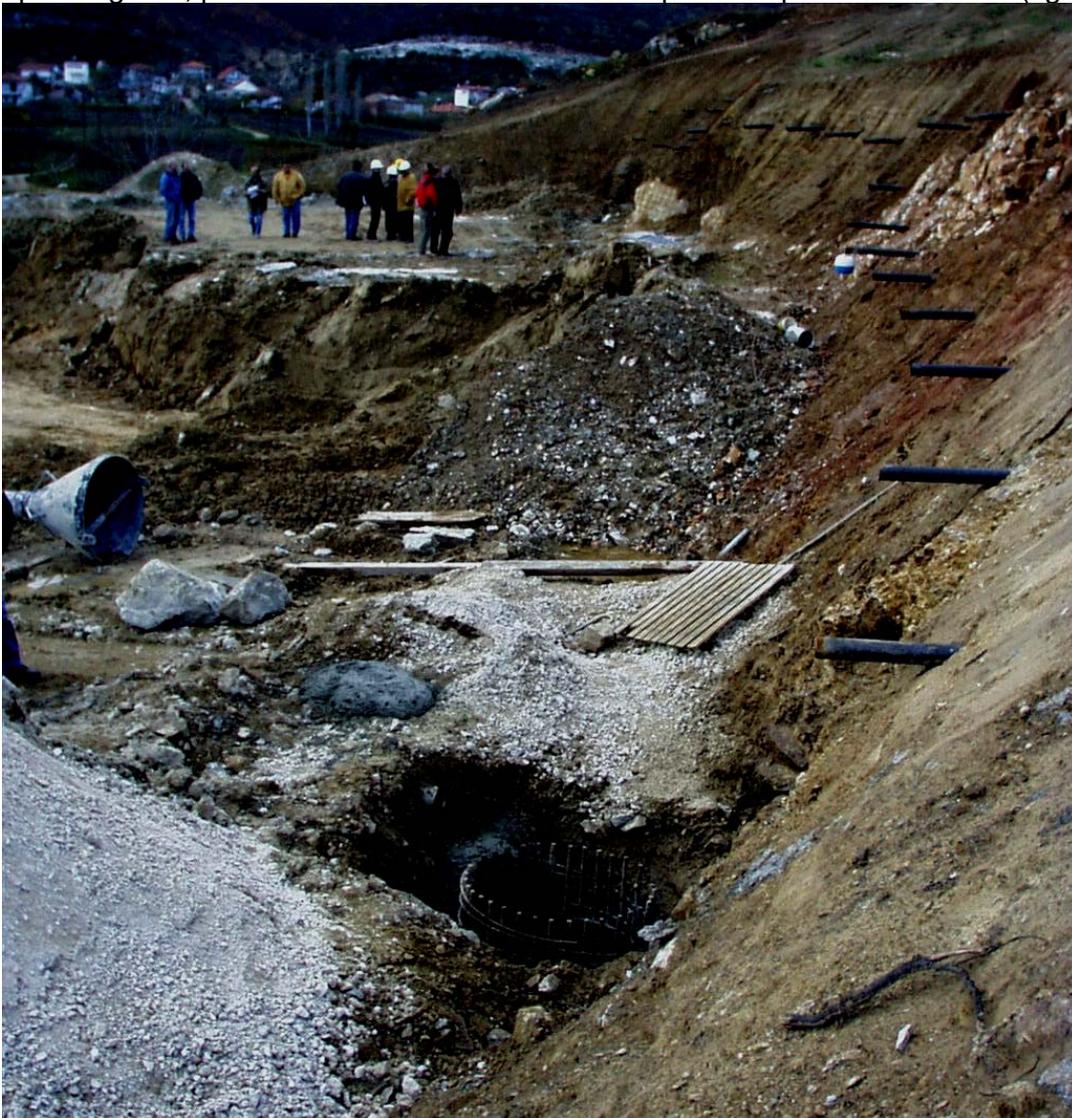
Figure 16: West portal excavation for S4 tunnel. Drainage pipes are shown projecting from the slope and a partially completed cast in place pile is shown in the foreground.

Special and heavy design was performed for the portals in these chaotic and unstable materials. For the stability of the west portal extensive drainage has been installed and is operating well; piles for reinforcement of the lower portal slopes were cast too (fig. 16).

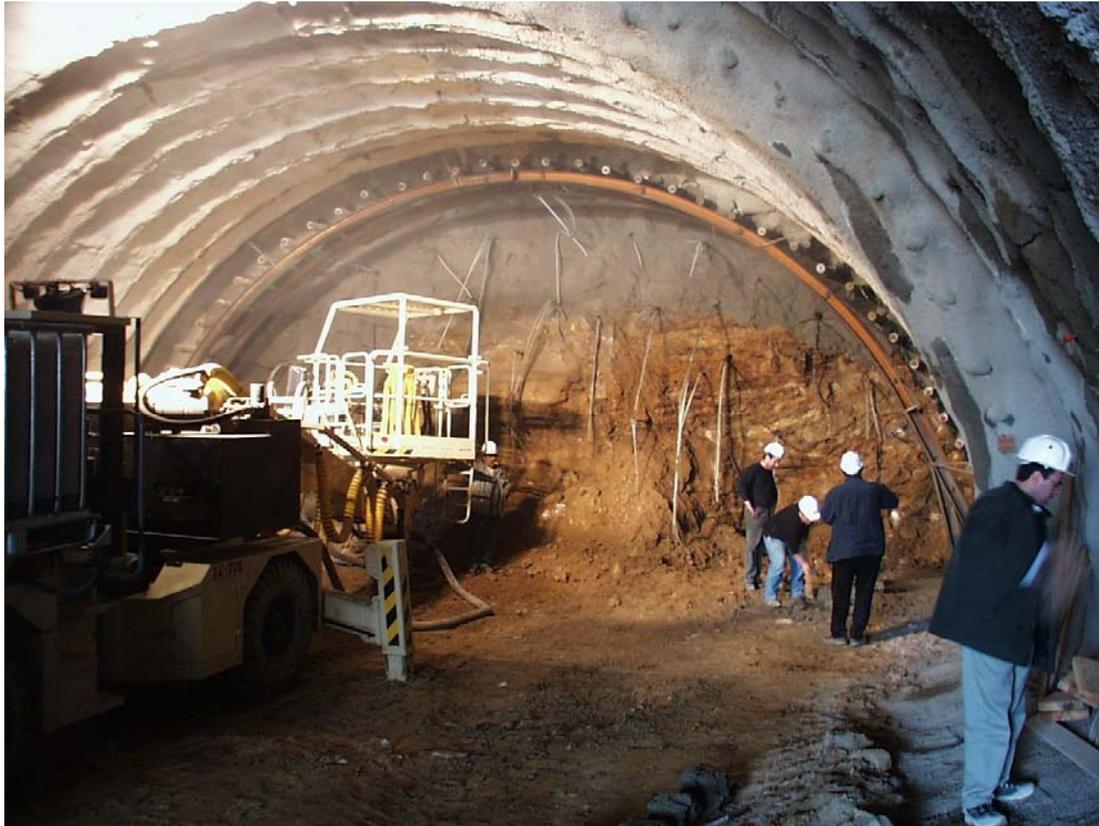
Figure 18: Appearance of face of tunnel S4 under construction. Depth below surface 40 m and maximum recorded displacement is 45 mm. Support: 12 m long 114 mm diameter forepoles at 0.6 m centres, steel sets with elephant foot support, fibre-reinforced shotcrete and fibreglass face reinforcement

In tunneling the rock mass was, as anticipated, heterogeneous and generally weak. According to the Designer, the face experienced in cases malanges as in the following table imposing heavy support (fig. 18)

Property	
GSI	5-15
σ_{ci} MPa	2
m_i	15
σ_{cm} MPa	0.05-0.11
E MPa	106-188
Friction angle	16-24
Cohesion (kPa)	20-40
Strength/stress ratio	0.046 - 0.1

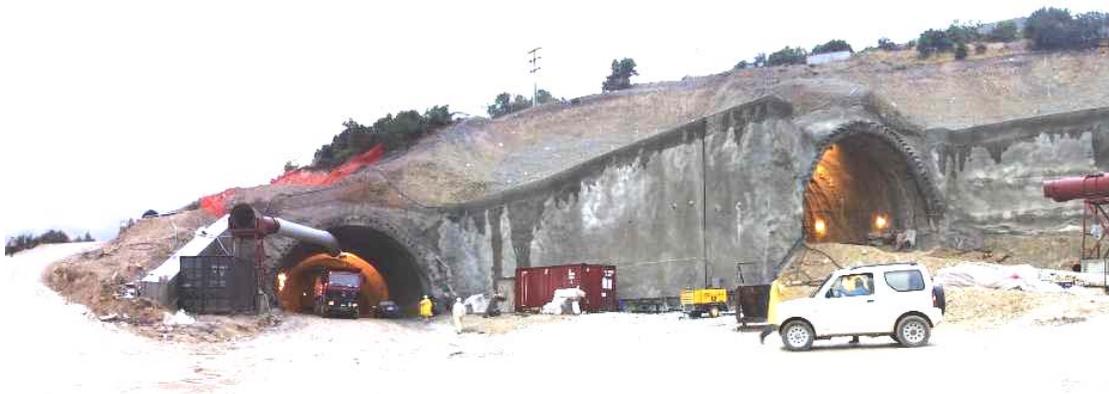
Figure 19: Current appearance of the portals for Tunnel S3 in Section 5.2.3. Note the very shallow cover over the tunnels.

During construction a number of cracks were observed in the slope above the portal excavations (fig. 19 and 120). In spite of the implementation of changes or support, cracks have continued to develop as the tunnels have been advanced.
