# **Contractual issues in Fast Track Tunnel Construction**

**The Albanian Motorway A1  
Rreshen-Kalimash Section  
Thirra Tunnel Experience**

## The Albanian Motorway A1 Rreshen-Kalimash, Durres – Pristine – Nis, Route 7

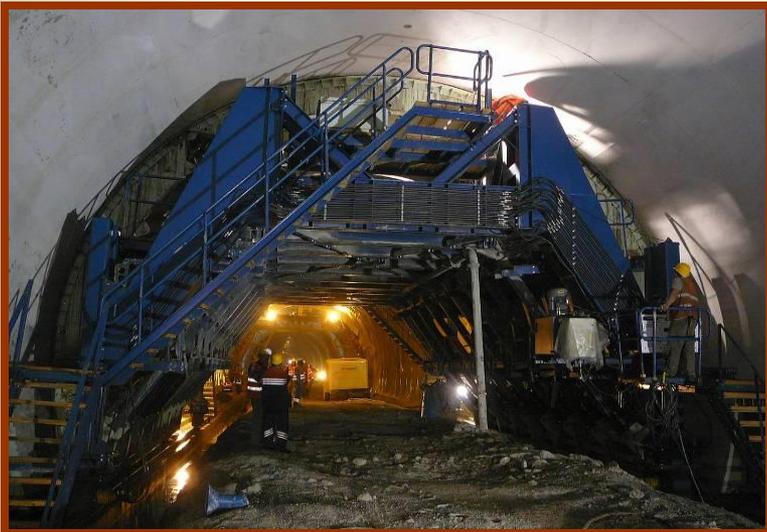
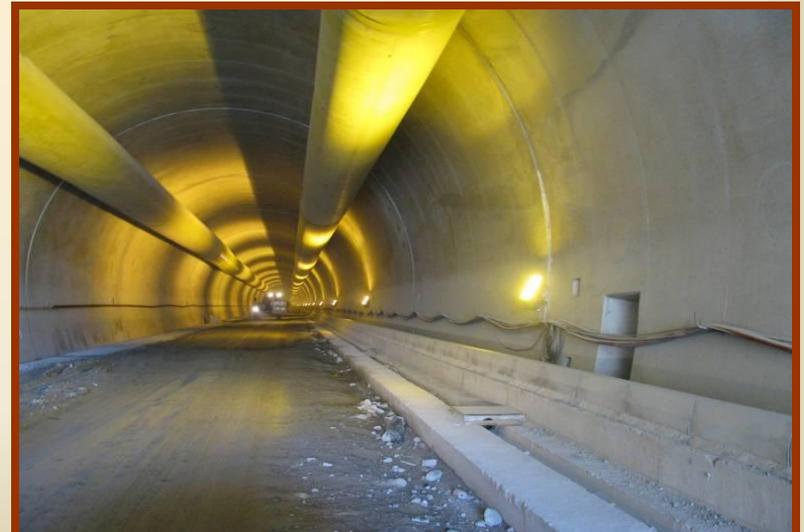
Formwork for lining

Finished lining

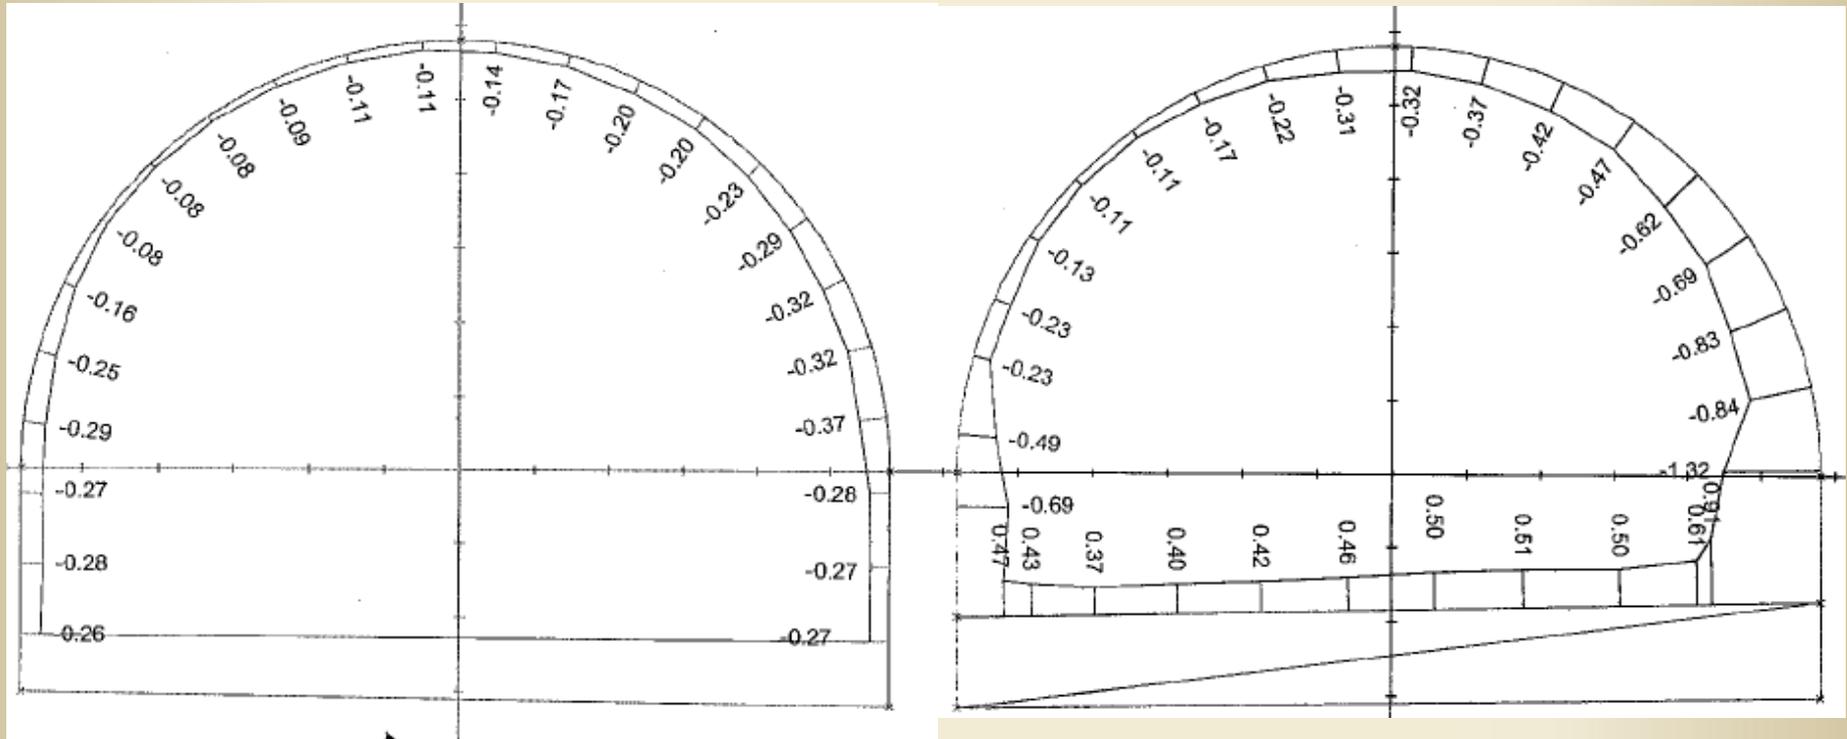
**Figure 3 -Tunnel profiles from the 08/06/2009 and the 15/08/2009 at KP 3+145 in North Tube**

Worrying deformation of the sides with 1,40m of displacement in 2 months

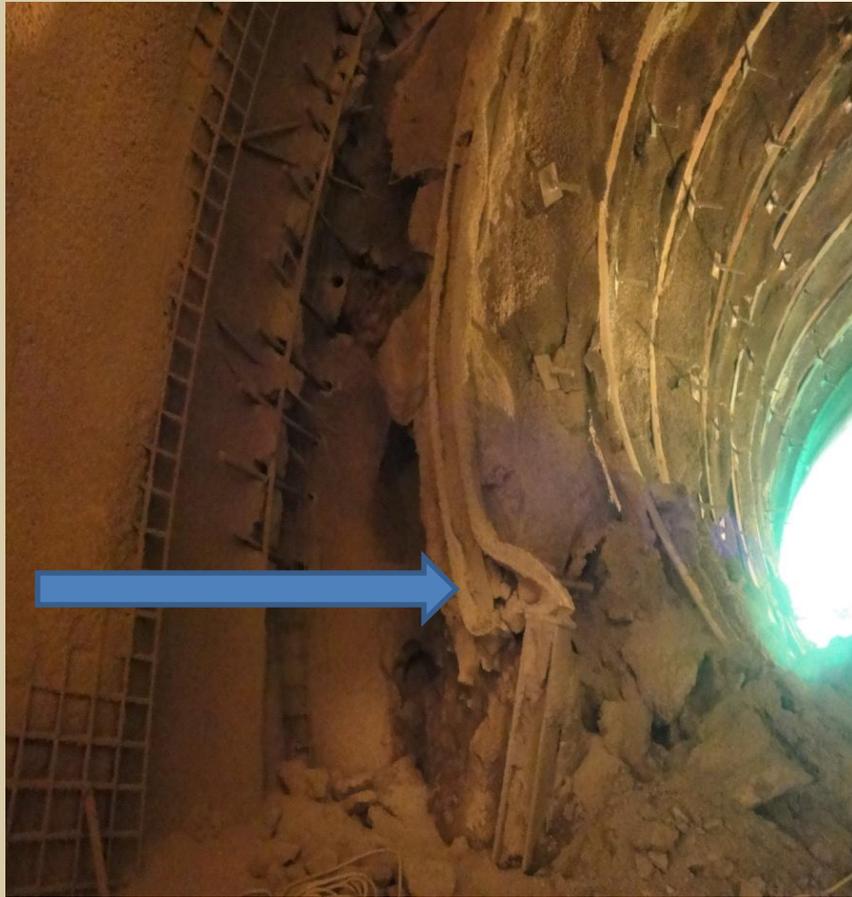
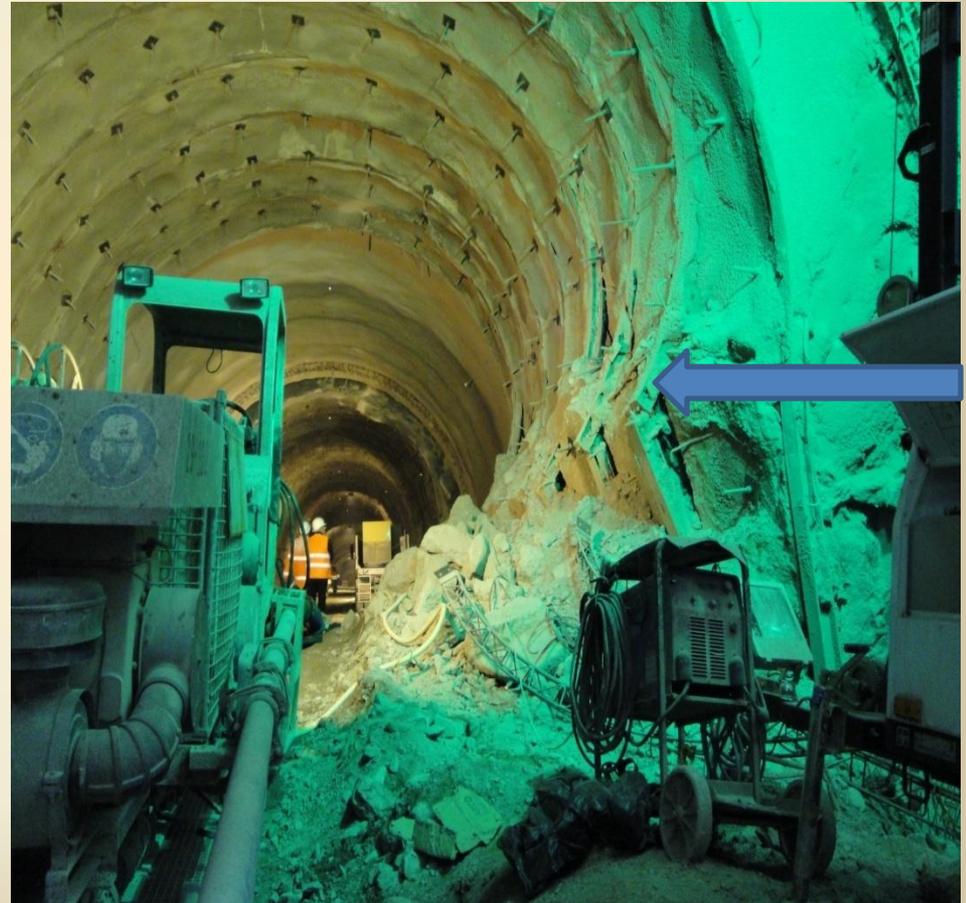
# Evidence of high deformations

- **The Rock Conditions Deteriorated in the Central Section of the Tunnel ( approx. 1 km).**
  1. Under increased pressure in the most heavily loaded section, the brittle, highly fractured rock, with sheared serpentinitised and slickensided joints, was unstable and prone to be possibly affected by the bolt drilling water.
  2. Convergence rates increased, rates of progress were reduced and the parallel excavation of the second tube caused serious secondary effects
  3. With deformations exceeding 50cm, the HEB steel arch supports were buckling and subsequently being destroyed by the forces upon them.

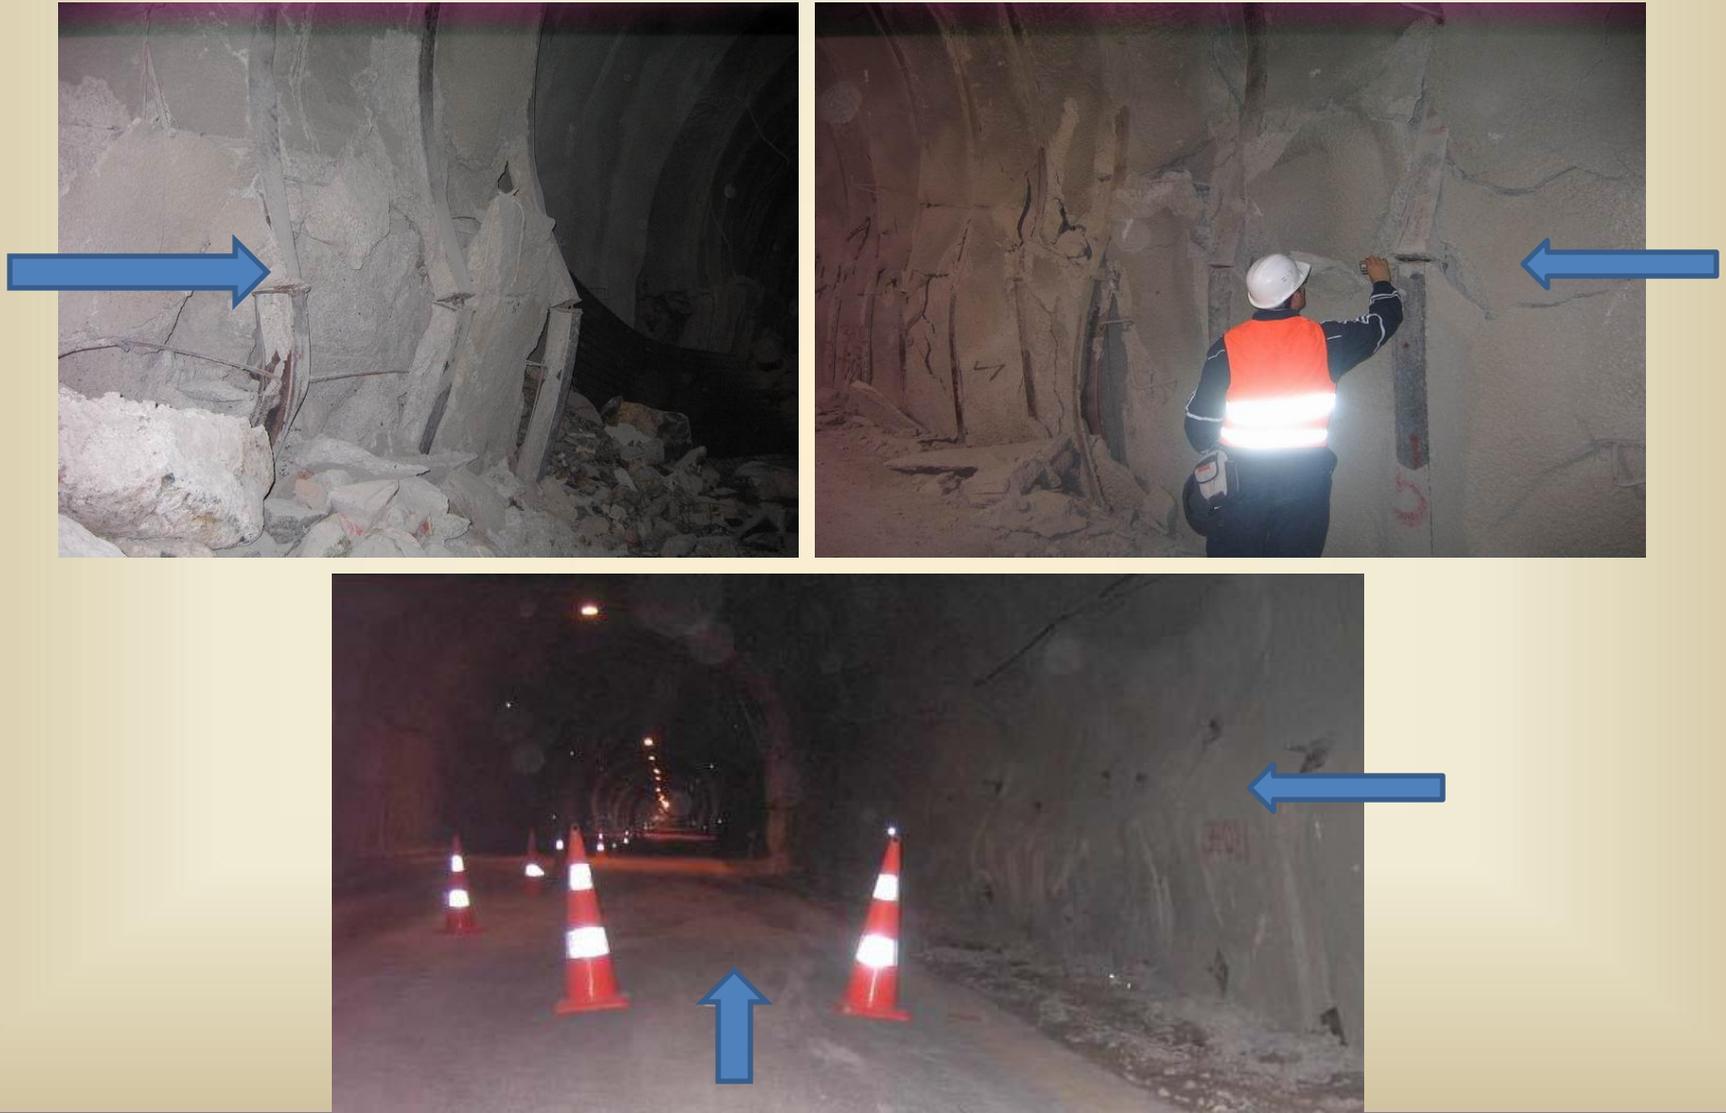
# Rupture of Primary Support and Up - heaving of Pavement

- **The Employer was Committed Opening the Motorway to Traffic by June 2009, before the Summer, Touristic Season.**
1. The emphasis was put upon stabilising the North tube with additional rock bolting to make it safe for public use.
  2. Continual convergence monitoring and daily rectification and maintenance works safely allowed the controlled passage to traffic throughout the summer season of 2009.
  3. The Designer re-appraised the situation and designed a close grid of 9m. rock bolts as the plastic zone around the tubes had extended beyond the limit of 6m. bolts.
  4. After bolting, the tubes would require re-profiling (which would destroy the bolts), and then re-bolting. A heavily reinforced lining would be required, at least 1m. thick.

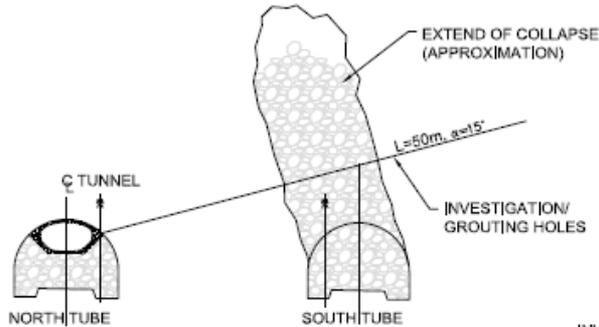
## SECTION A-A

- **On 5<sup>th</sup> November 2009, there was a partial collapse some 60m Long in the South Tube.**
1. The cause was that a wedge shaped section of rock squeezed out under pressure with consequential unravelling of the rock matrix on either side.
  2. The collapse happened in a section that had developed an irregular cross section due to convergence and the breakout of loosened material.
  3. It was not in an area that was being worked and it caused no injuries.

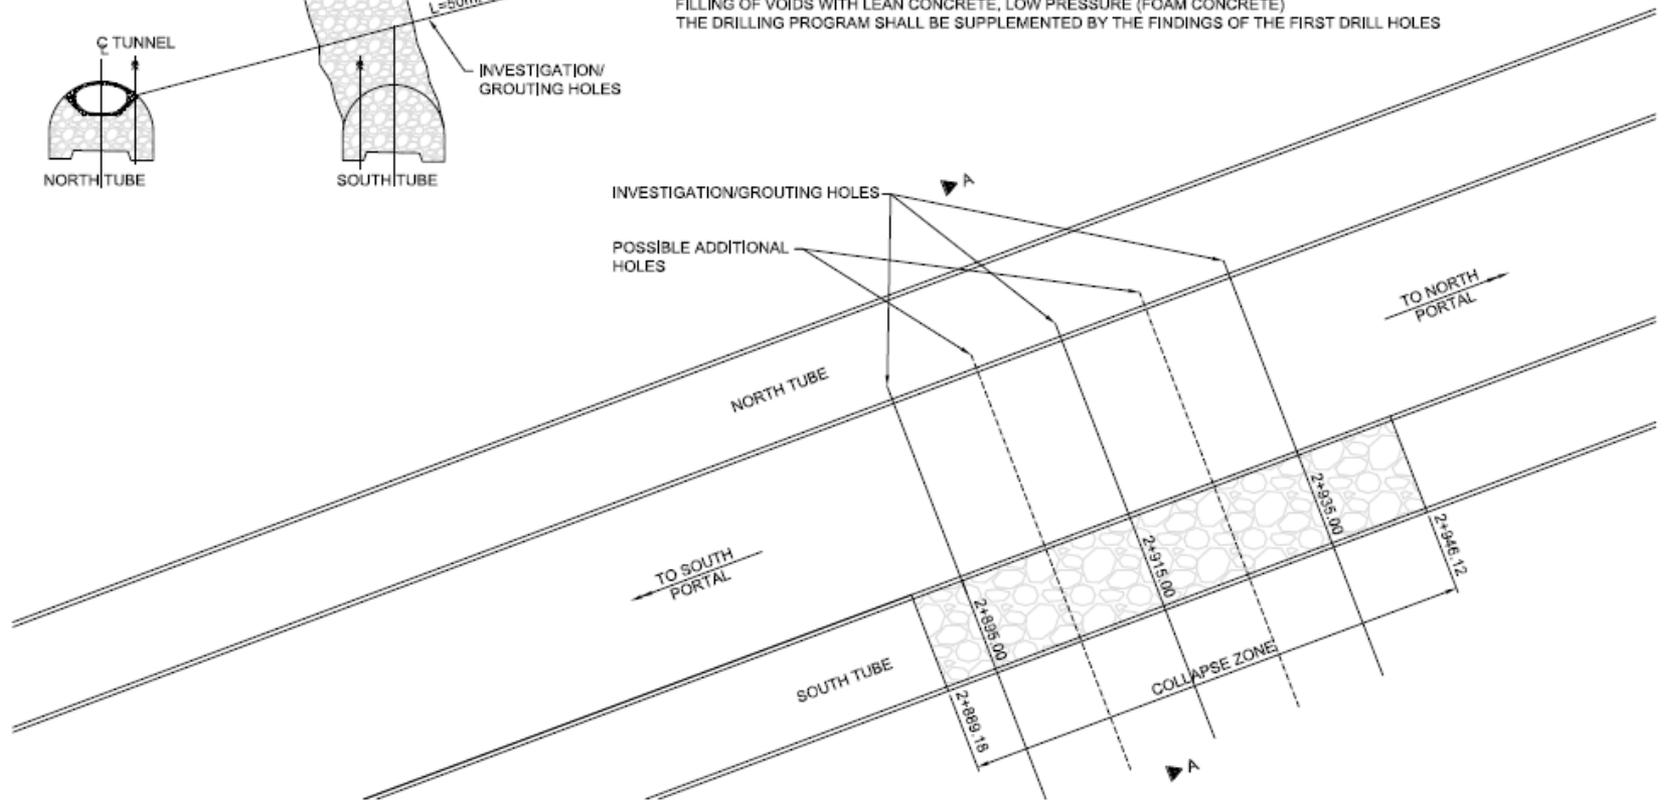
## COLLAPSE INVESTIGATION

INVESTIGATION AND GROUTING HOLES :  
 HAMMER DRILLING, DRY FLUSHING, CASING  
 FILLING OF VOIDS WITH LEAN CONCRETE, LOW PRESSURE (FOAM CONCRETE)  
 THE DRILLING PROGRAM SHALL BE SUPPLEMENTED BY THE FINDINGS OF THE FIRST DRILL HOLES

1. The Sub-consultant primarily took issue with the tunnel shape and with the inflexibility of the rigid HEB arch girder geometry, as a primary support system.
2. He opted for using lattice girders, wire mesh and shot-crete in conjunction with the NATM observational methodology.
3. The collapse was tunnelled through by means of concrete capping of the void cone and fore-poling shielding of the excavation made through the fallen material.

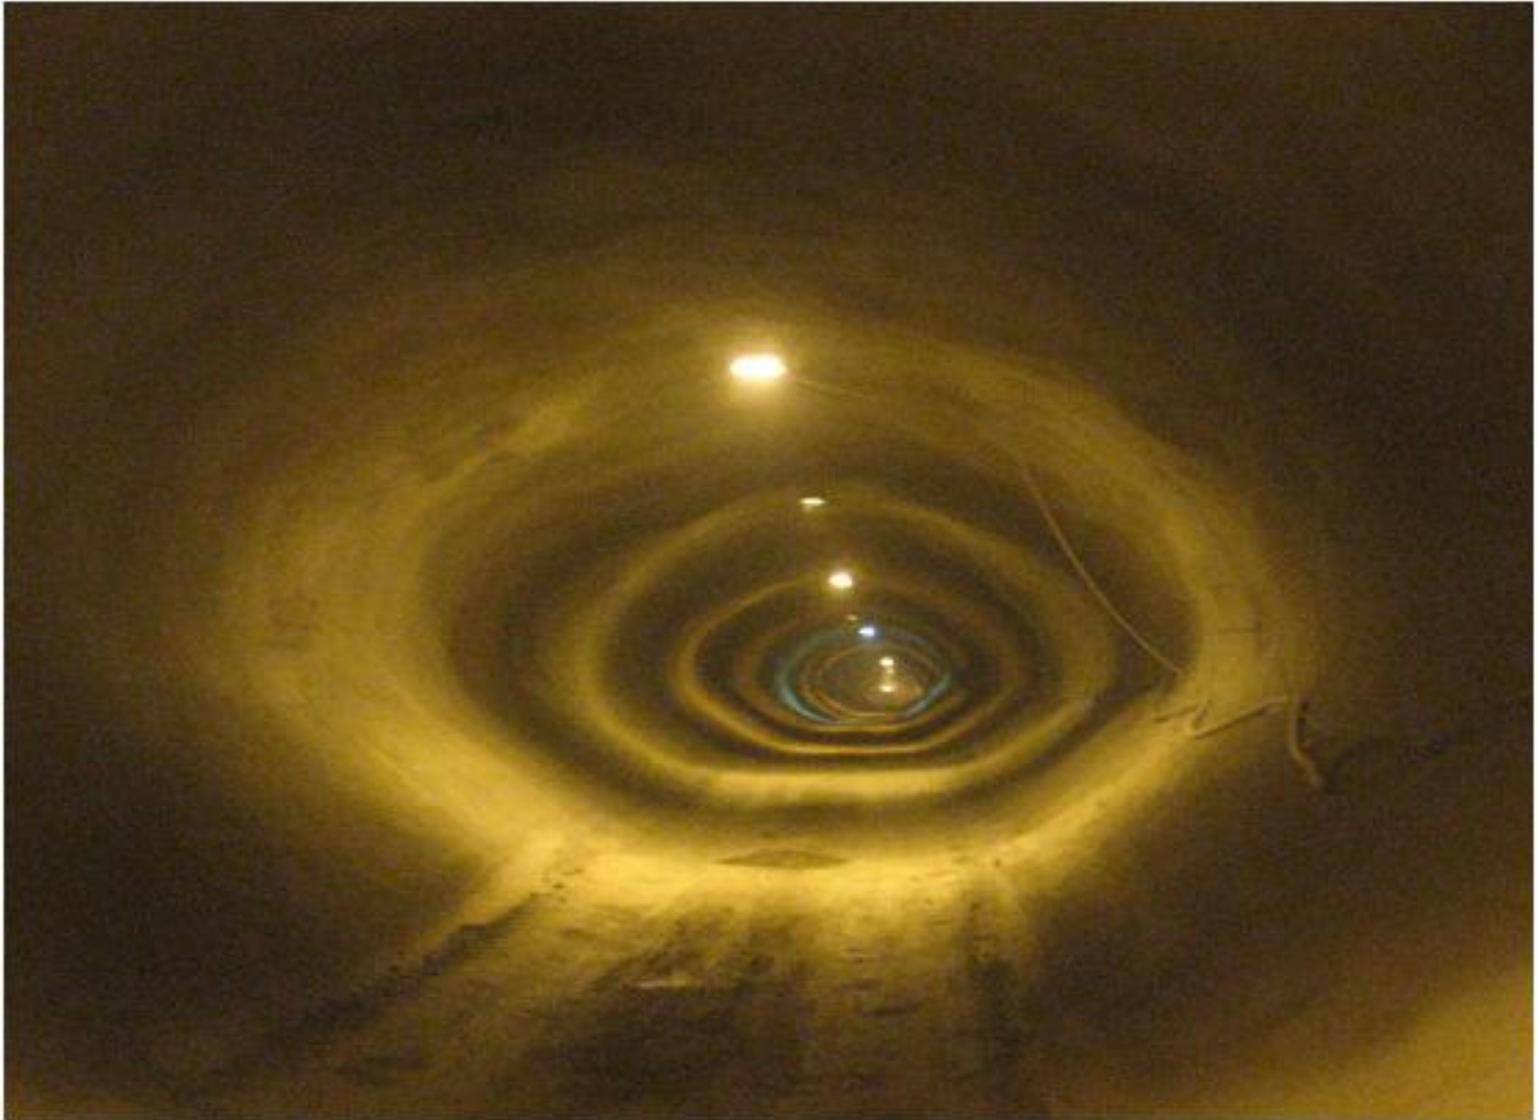
# Safety measures in the North tube

- **The Pattern of Faults Causing Problems in the Central Section was Promptly Identified by the Sub-Consultant.**
  1. To block the convergence, the tunnels were partially backfilled through the critical area, leaving sufficient height for access.
  2. The crown above the access road was supported by forming substantial, ovoid shot-crete arches.
  3. It was a completely effective solution.

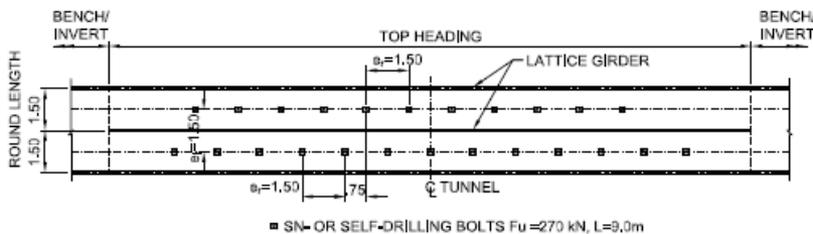
**ROCK BOLTING SCHEME**  
SCALE = 1:150

SPLICE BARS; Ø12, L=1,0m  
5 per ROUND

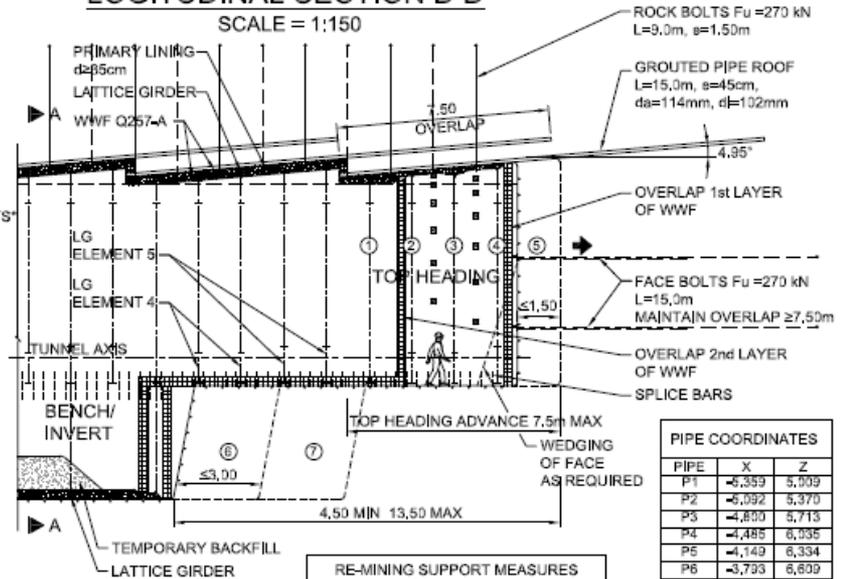
**LOGITUDINAL SECTION B-B**  
SCALE = 1:150

RE-MINING SUPPORT MEASURES	
	TOP HEADING	BENCH/INVERT
Round Length	≤ 1,50m	≤ 3,00m
Pre-Support	Grouted Pipe Roof Ø114, L=15m, e=45cm Grouted IBO Bolts* Ø32 L=4m, e=25cm	—
Shotcrete C25/30/F5	≥ 35cm	≥ 35cm
Reinforcement	2 Layers Q257-A	2 Layers Q257-A
Rock Bolts Fu = 270 kN	Spacing	e=1,50m, e=1,50m
	Length	L=9,0m
Lattice Girder	Typ	130-30-20 A≥13,3cm²
	Spacing	≤ 1,50m
Face Bolts	L=15,0m, Fu=270kN, Overlap ≥7,50m	
		—
