# **The Maliakos-Kleidi Motorway (MMK) Tunnels**

## ***Geotechnical Conditions and Construction Experience***

❖ **N. KORONAKIS , P. KONTOTHANASSIS & P. MANTZIARAS**

***(OK CONSULTING SA, Greece)***

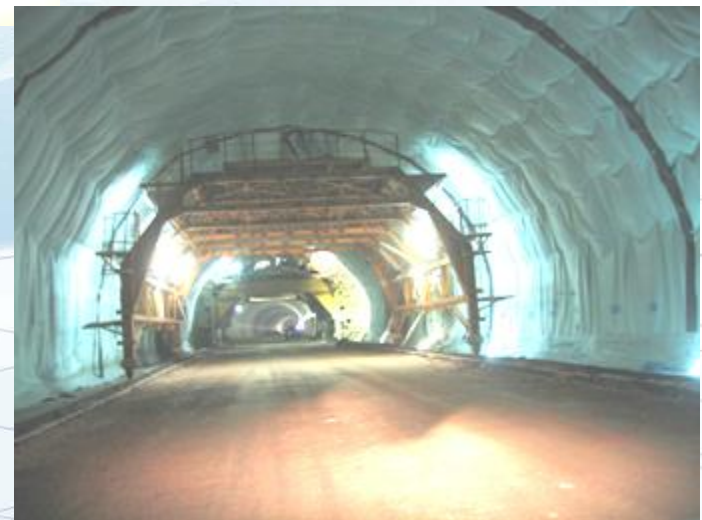
### Application ~ 20% of the project

- ❖ Tunnel T1: 1.46 km out of 3.85 km
- ❖ Tunnel T2: 3.37 km out of 11.94 km
- ❖ Tunnel T3: 0

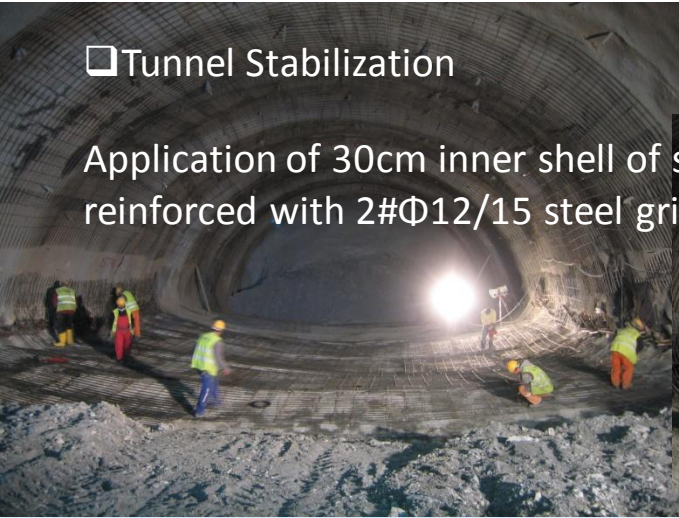
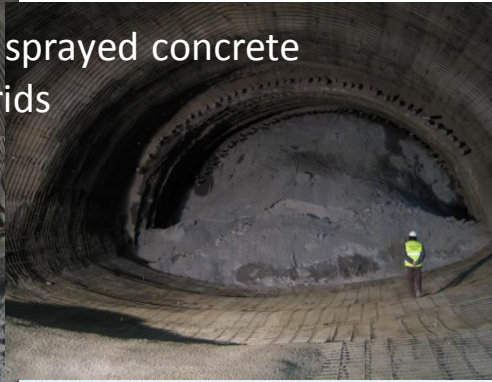
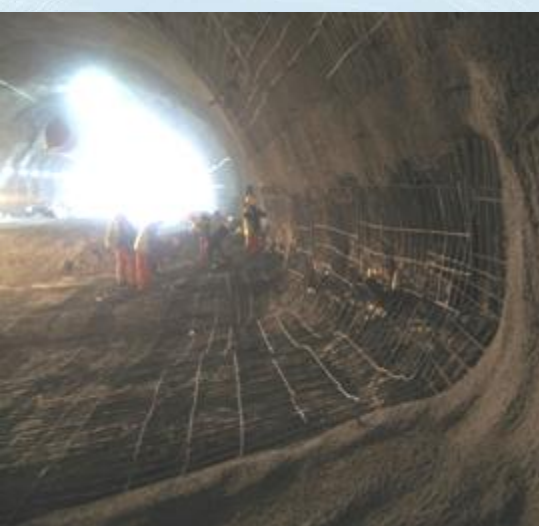
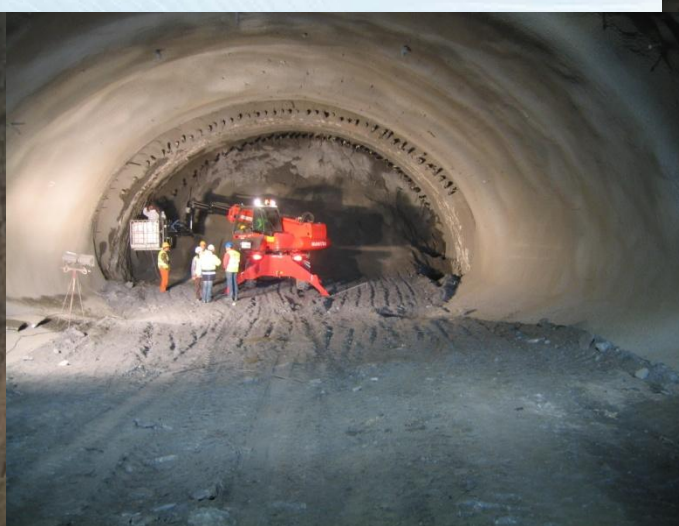
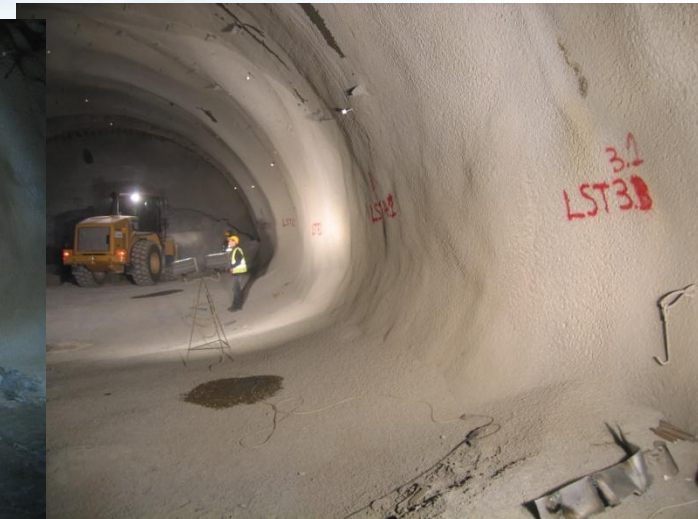
### □ Tunnel Stabilization

Application of 30cm inner shell of sprayed concrete reinforced with 2#Φ12/15 steel grids

- ❖ Top heading excavation in shattered phyllites GSI~10
- ❖ medium overburden 70m
- ❖ Severe face instabilities (impossible to address with standard methods, such as: face buttress, intense fiberglass face bolting etc)
- ❖ Adverse stress environment
- ❖ inability to timely implement the support measures for the cavity
- ❖ early development of high convergences evidence of interaction between the SB and NB

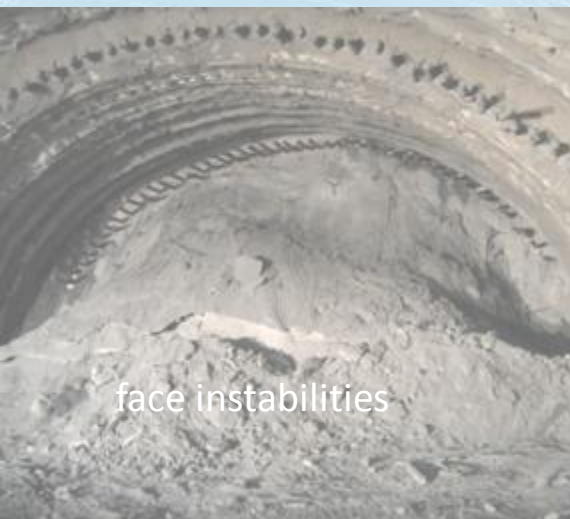
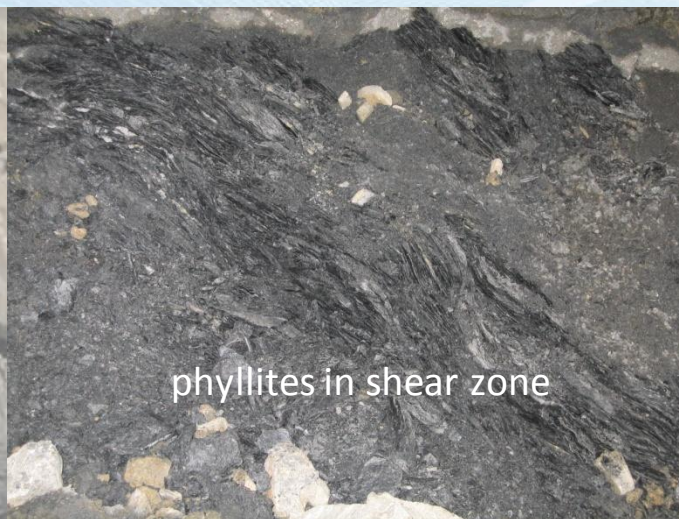
Captured convergence

– profile measurements

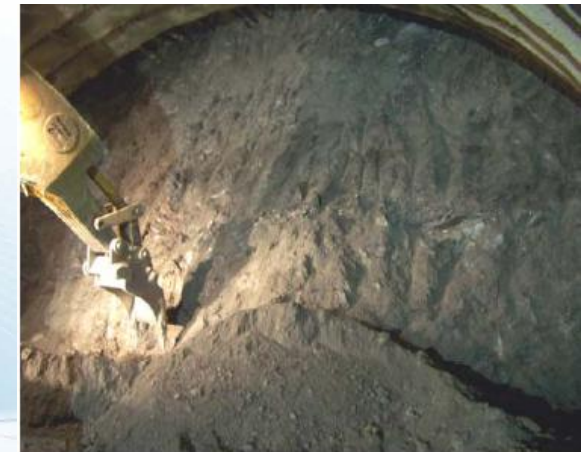
*(top heading excavation in very weak slickensided peridotites GSI~15, low overburden area~20m from the crown)*

- NB tunnel failed for 40m
- surface crater – surface subsidence impact as broad as 6 acres
- Nat. Gas Pipeline inside the settlement trough
- contingency actions to secure the SB tunnel – backfilling
- installation of surface monuments
- identification of site conditions by detailed site investigation
- rehabilitation Design

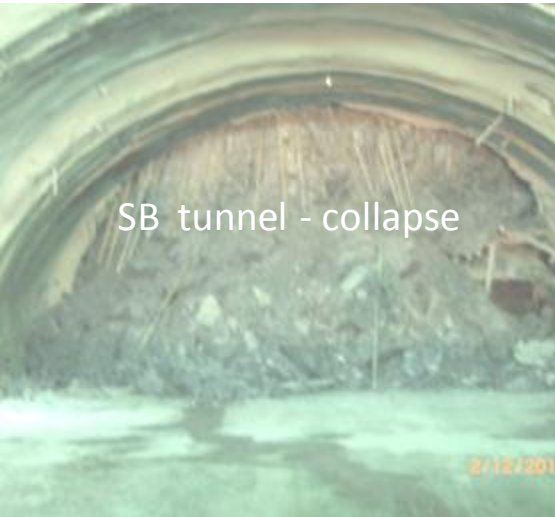
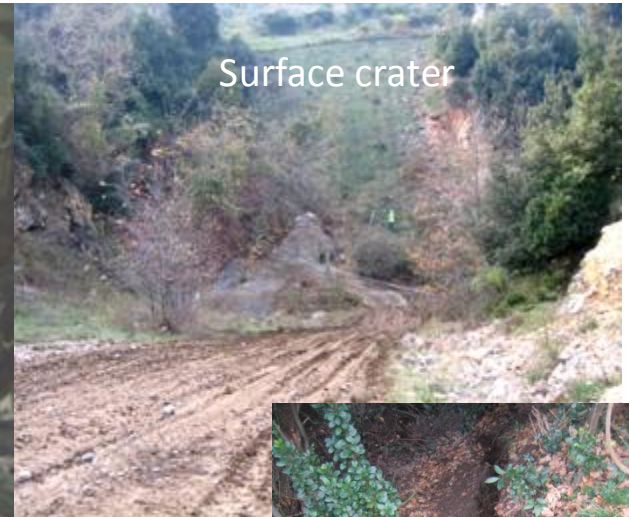
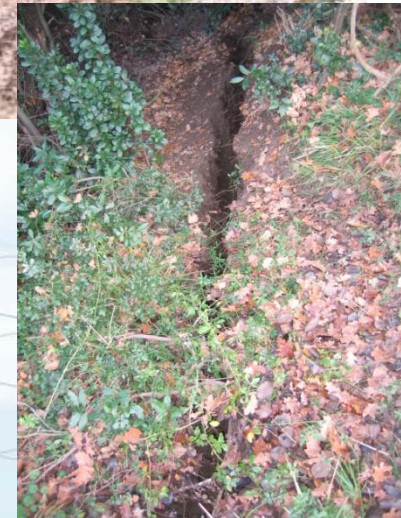
Surface subsidence footprint (6.000m<sup>2</sup>, mean settlement 0.50m)

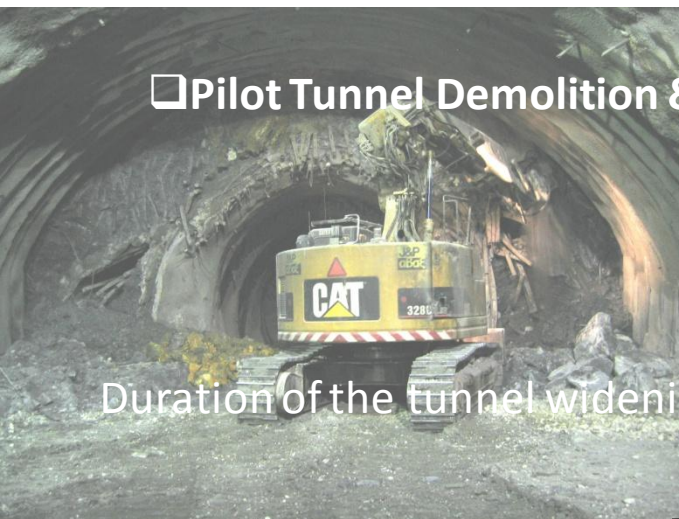
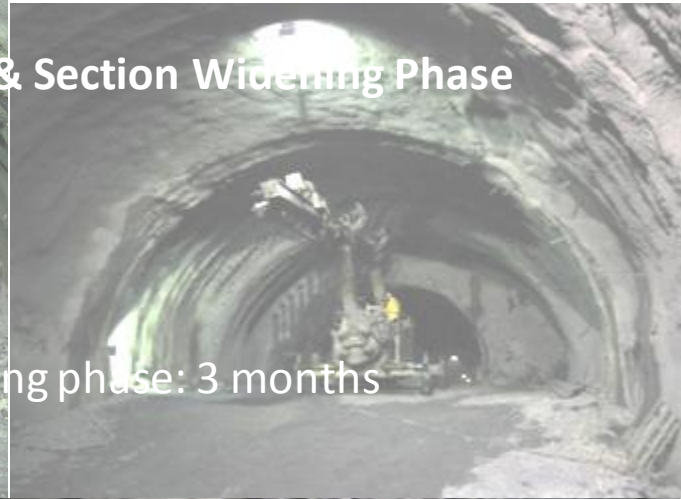
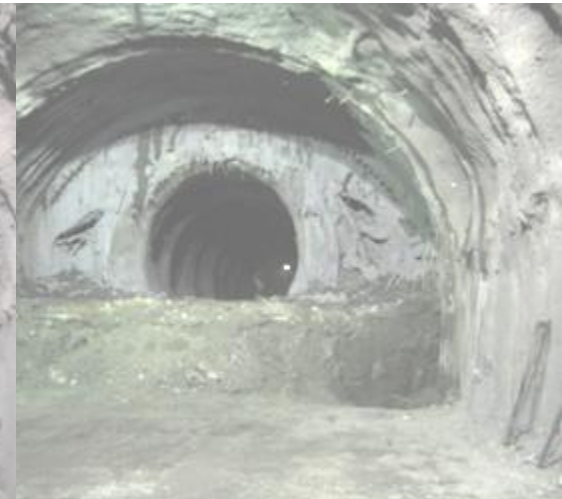
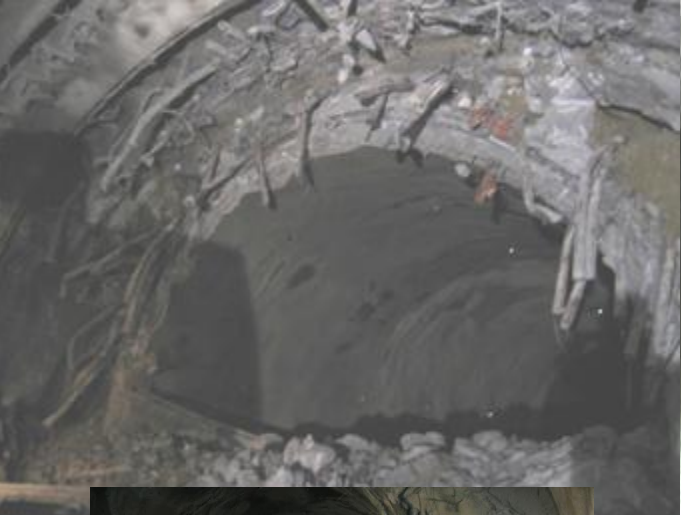
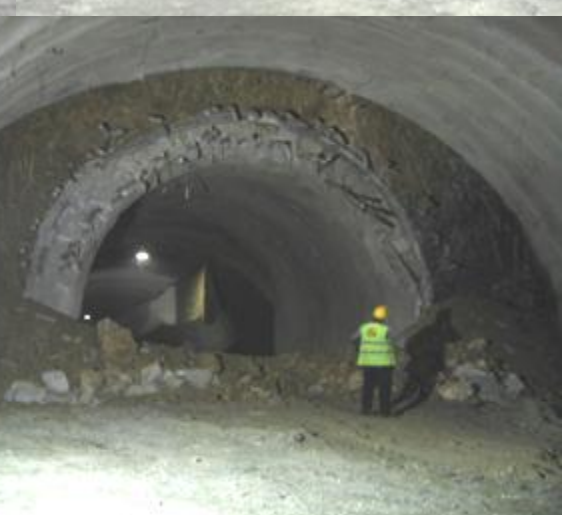
## ❑ Pilot Tunnel Demolition & Section Widening Phase

Duration of the tunnel widening phase: 3 months

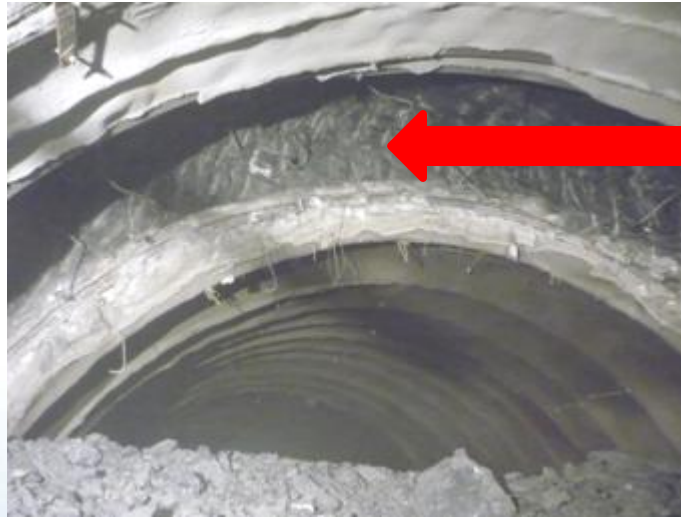
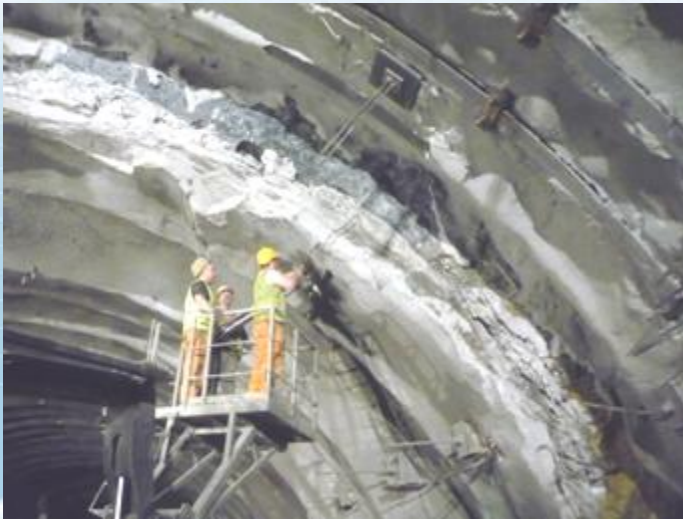
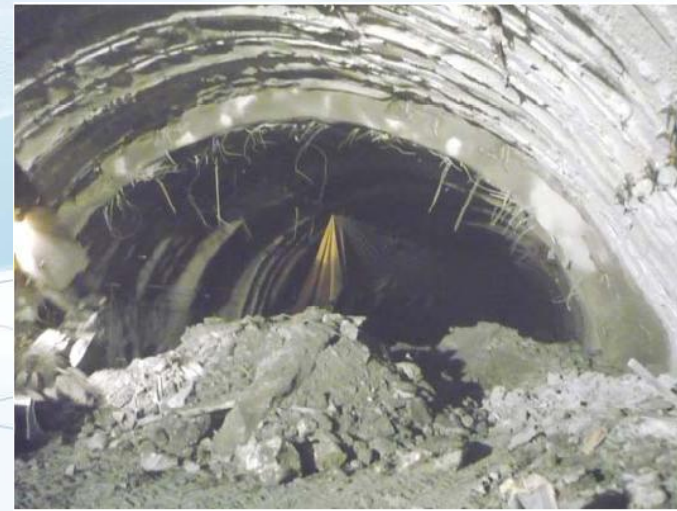
← amount of convergence

- **an outer shell**, a composite sprayed concrete lining 25cm thick with LG140/30/200 embedded per 0.50m rounds
- **an inner shell**, a composite sprayed concrete lining 25cm with HEB180 arches embedded, in 1m rounds
